INSPECTION REPORT

FACILITY: ASARCO East Helena Plant
P.O. Box 1230, E. Helena, MT 59635
EPA ID # MTD 006 230 346
Telephone (406) 227-7191

DATE OF INSPECTION: November 4 & 5, 1998

PURPOSE OF INSPECTION: To evaluate ASARCO's compliance with RCRA requirements. The inspection focused on secondary material management and on-site waste generation activities.

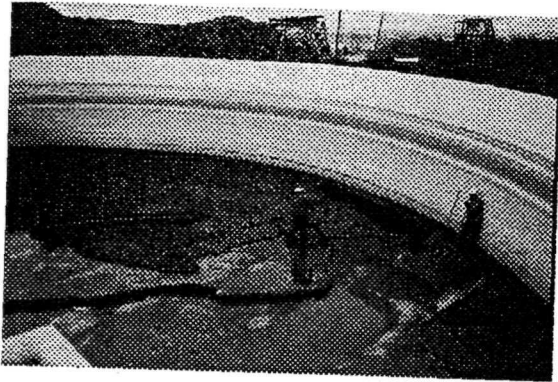
At the million gallon tanks the inspection team observed the removal of sludge from the bottom of the north tank. The sludge was 6" to 1' thick. The sludge was removed using a vacuum truck. Mr. Nickel stated that the sludge was stored in bins by the blast furnace flue on the east side of the facility. The sludge is dried in the bins and then sent to the blast furnace.

1. Removal of sludges from 1 million gallon tank

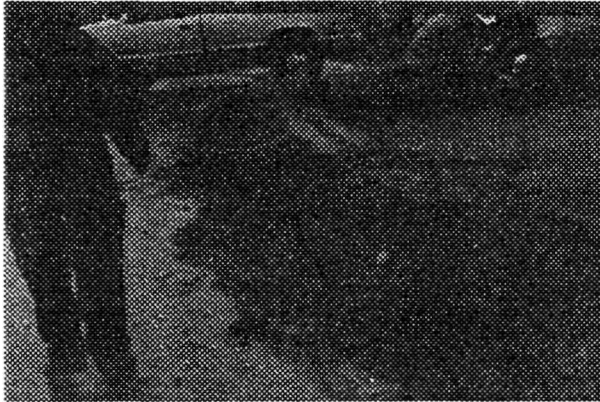
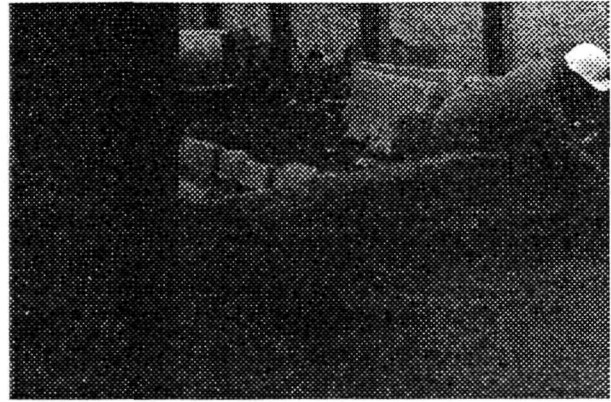
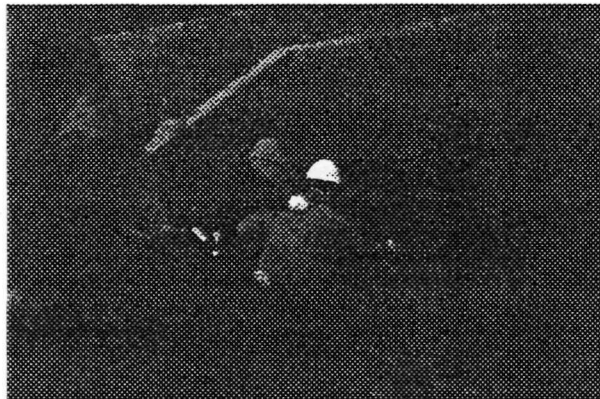
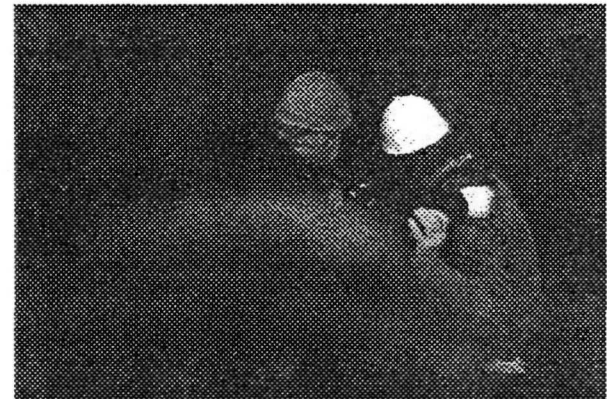
The State obtained samples of the sludge. Mr. Potts collected composite samples. A sample of the material leaking from the toe of the berms was not obtained. Photographs attached. See the DEQ's report.

Photos #4-#7, sampling of sludges from 1 million gallon tank.

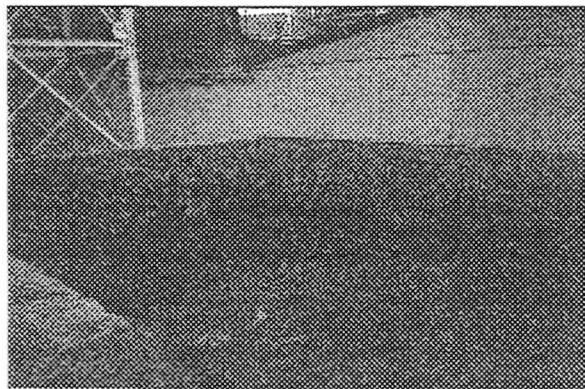
The team then proceeded to the storage bins. There were 3 bins approximately 20 feet by 20 feet on the west wall of the blast furnace flue. The sludge was approximately 2 feet thick in each of the bins. The outer edge of the bins was an approximately 3 foot high berm of lime rock. There were 2 bins on the south wall of the used oil storage building, just across the road from the bins along the flue. These 2 bins were approximately 20 feet by 20 feet with an approximately 4 foot high berm of lime rock. The sludge was approximately 3 feet thick. On the south edge of the 3 bins along the flue there was a pile of semi dry sludge.

8. Storage bin on south side
of used oil storage area
